FINAL REPORT
DEVELOPMENT OF IMPROVED GRAPHITE
FIBER COMPOSITES

14 April 1972 - 11 May 1973

Prepared for: Naval Air Systems Command
Washington, D.C.

Under Contract: N00019-71-C-0166

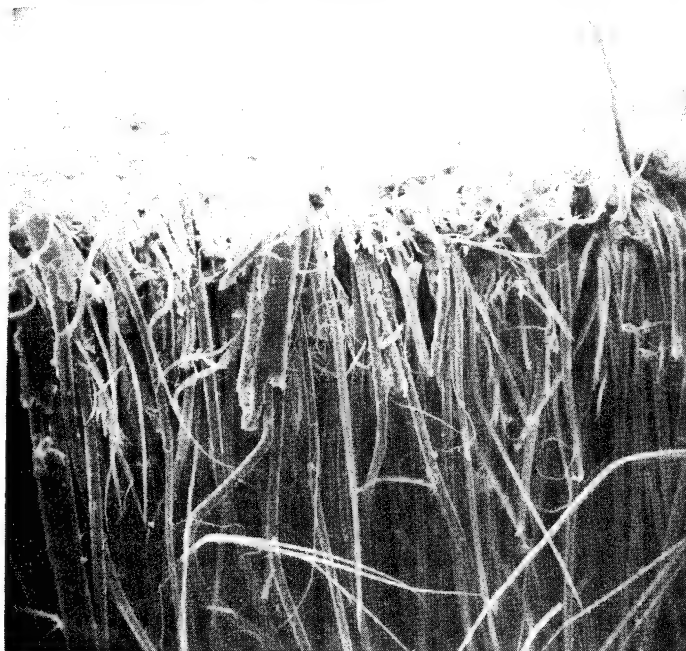
FIGURE 23. 238X SEM - TENSILE SIDE OF IMPACT SURFACE PANEL #2, PRD-49, TYPE III

Figures 23 and 24 depict the impact fracture surface associated with PRD-49 III, panel No. 2. A high degree of fiber debonding and pullout in Figure 23 is present. A close examination of a fractured PRD-49 fiber in Figure 24 shows that the fiber has undergone a complete catastrophic failure over a considerable length of the fiber. In addition to absorbing energy by debonding, the PRD-49 fiber shows an ability to absorb relatively larger amounts of energy during fracture because of the very nature of its type of failure. The smooth appearance of the impression left by the PRD-49 fiber in the matrix at the left edge of the fractured fiber should be noted. Figure 31 also shows the smooth surface associated with a PRD-49 fiber. This smoothness of the PRD-49 fiber surface prevents the high degree of mechanical interlocking of fiber to matrix and subsequently is a cause for the reduced transverse tensile and interlaminar shear strengths (the other principal cause being a relatively lower degree of chemical bonding).
